## What Do Orange Stakes, Old Photos and Cooking Lake Water Levels Have in Common?

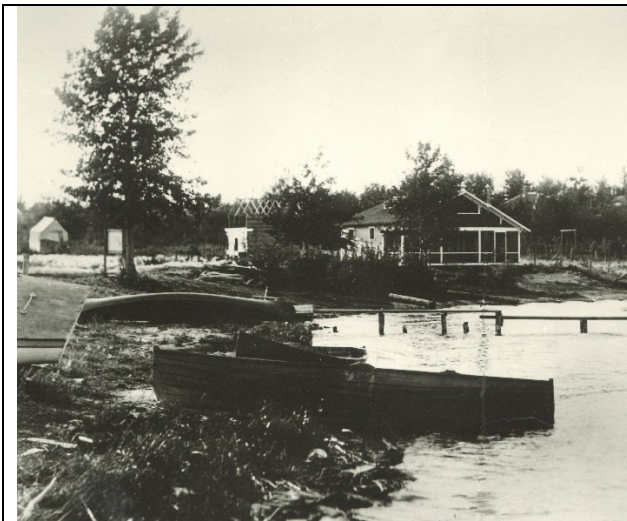
**Manning Cottage – 1915 or 1916**

For example, the Manning cottage at South Cooking Lake was photographed first in 1915 or 1916. It was re-photographed in 2021 and the new image combined with the old. Orange stakes were then placed and the location of the old water's edge was determined and measured.

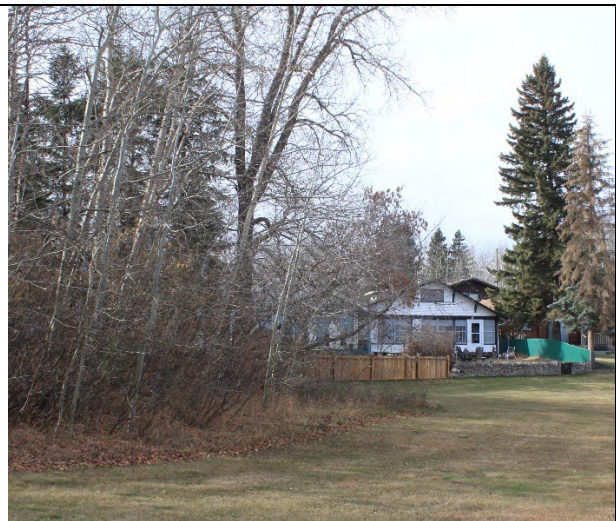
**Manning Cottage - 2021**

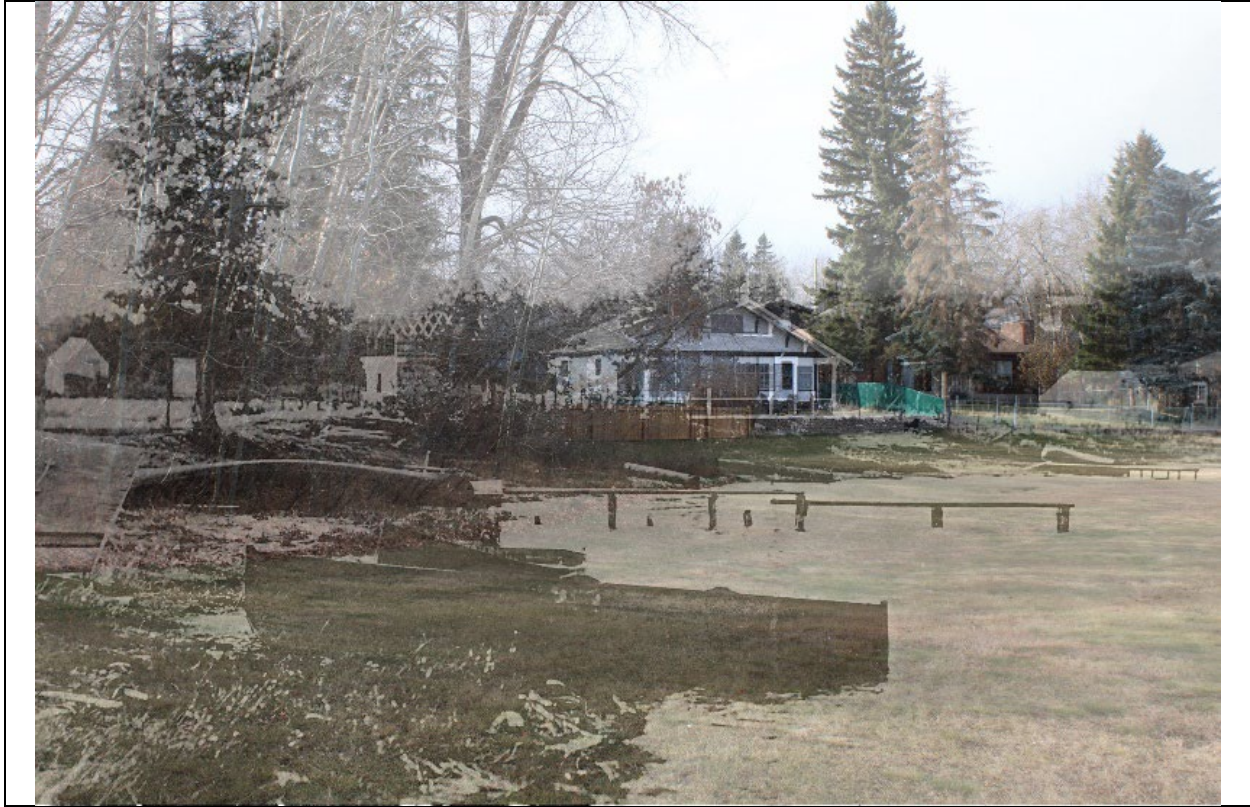
**Combined photos from 1915/16 and 2021**

The water height in 1915/16 was estimated to be 737.6m, a level consistent with actual measurements taken in 1916. Today the water level is 734.0m. The difference is 3.6 m or 11.8 feet.
