Cooking Lake – The Disappearing Lake.

This document provides a summary of work undertaken to-date, and interim findings. Work continues. Recommendations, future work needed and current data gaps are also identified.

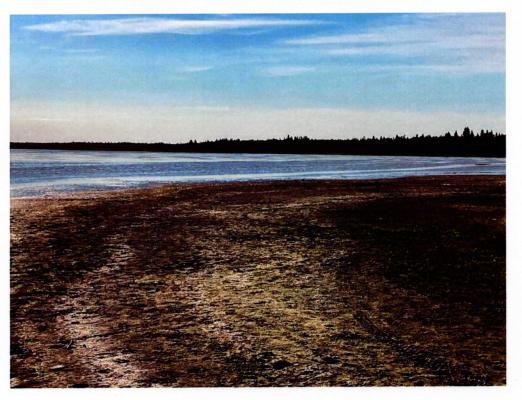
Photo 2: Mudflat at Plover Point (2022)

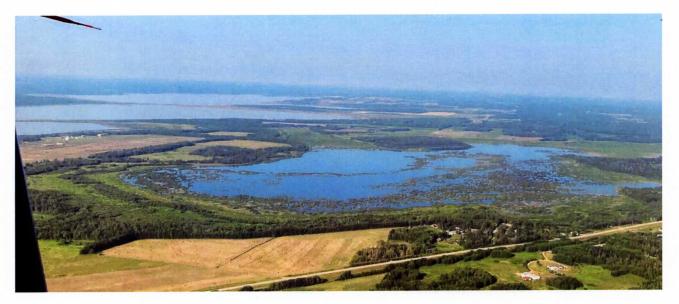
Photo 4: The north basin of Cooking Lake. Shallow marsh with no connection to the south basin, in the background. (2022)

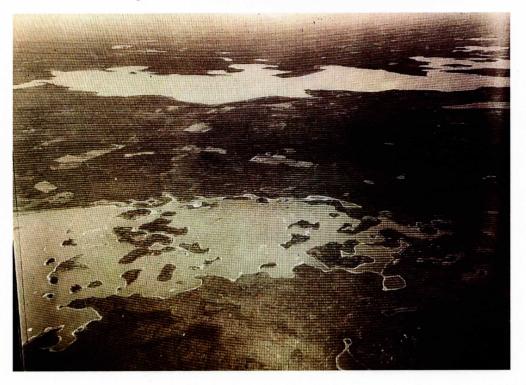
Photo 6: Cooking Lake, in the background, as it was in 1924. (oblique aerial photo Govt of AB). Note -Ministik Lake, also full of water, in the foreground.
